# New Hampshire Volunteer Lake Assessment Program

## 2003 Biennial Report for Spofford Lake Chesterfield

NHDES  
Water Division  
Watershed Management Bureau  
29 Hazen Drive  
Concord, NH 03301

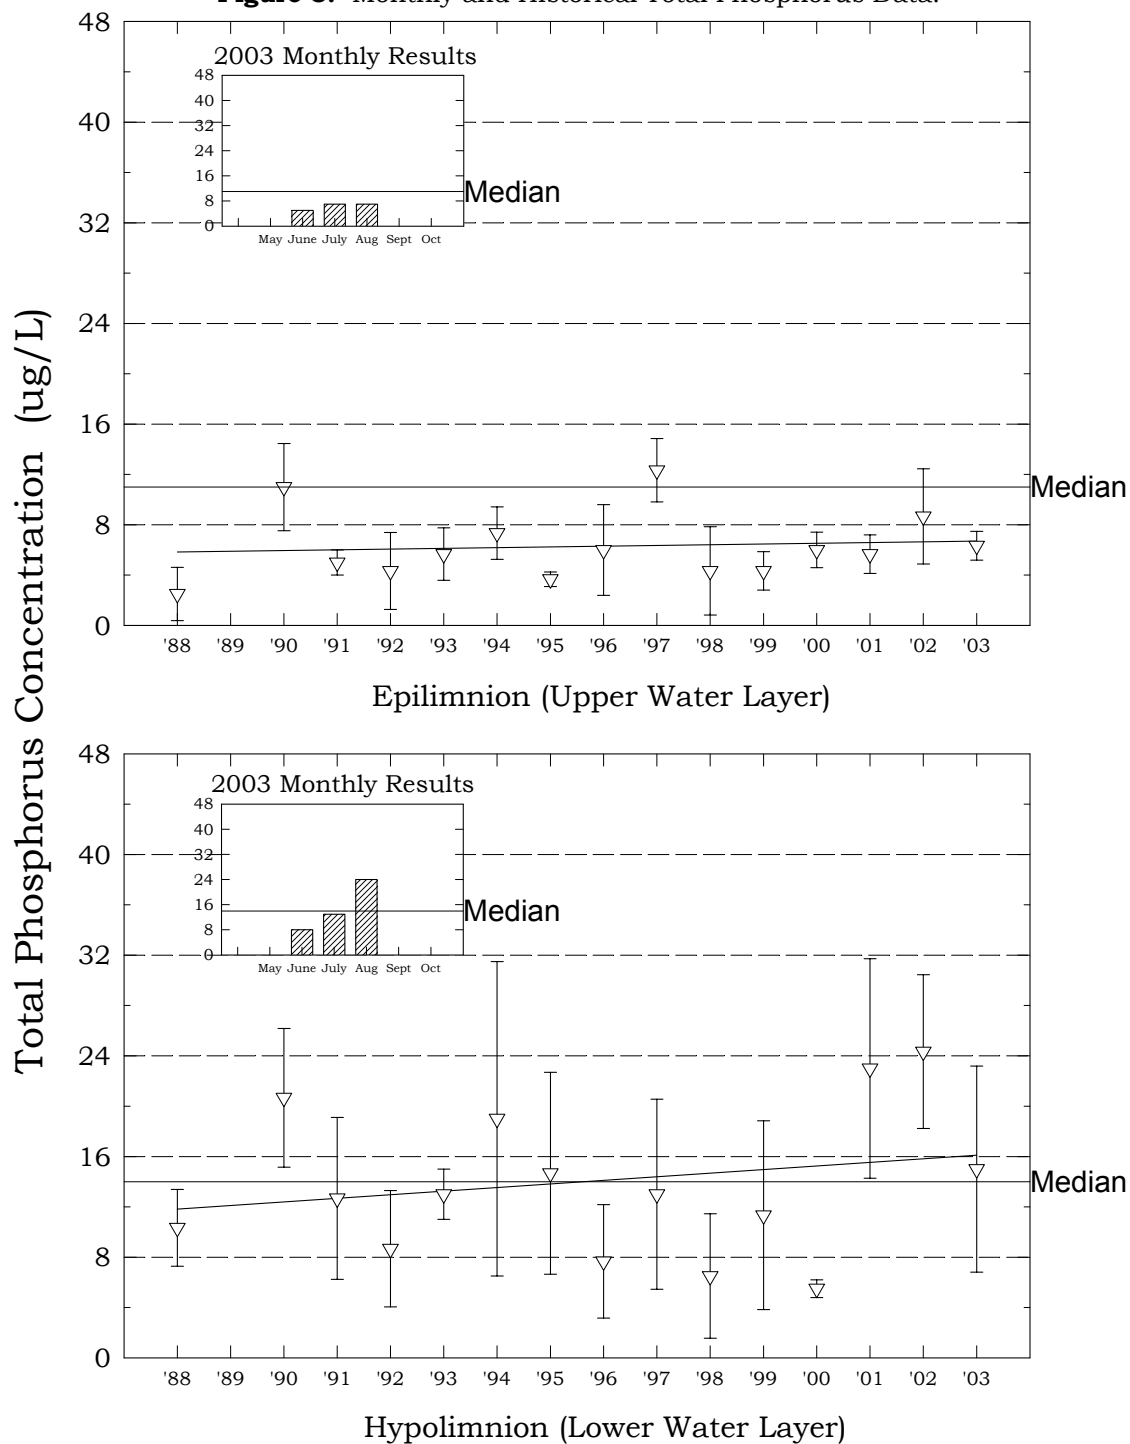
**Figure 3.** Monthly and Historical Total Phosphorus Data.

- **Figure 3 and Table 8:** The graphs in Figure 3 (Appendix A) show the amounts of phosphorus in the epilimnion (the upper layer) and the hypolimnion (the lower layer); the inset graphs show current year data. Table 8 (Appendix B) lists the annual maximum, minimum, and median concentration for each deep spot layer and each tributary since the lake/pond has joined the program.

The current year data for the epilimnion (the top inset graph) show that the phosphorus concentration **increased slightly** from June to July, and then **remained stable** from July to August. The phosphorus concentration on each sampling event was **less than** the state median.

The current year data for the hypolimnion (the bottom inset graph) show that the phosphorus concentration **increased consistently** from June to August. The phosphorus concentration in August was **greater than** the state median.

The historical data show that the 2003 mean hypolimnetic phosphorus concentration is **approximately equal to** the state median.

Overall, the statistical analysis of the historical data show that the phosphorus concentration in the epilimnion (upper layer) and the hypolimnion (lower layer) has **not significantly changed** since **1990**. Specifically, the phosphorus concentration in the epilimnion has remained **relatively stable** and has been **less than** the state median. The phosphorus concentration in the hypolimnion has **fluctuated**, but has not *continually increased* or *decreased* since monitoring began. (Note: Please refer to Appendix E for the statistical analysis explanation and data print out.)
